DOCUMENTATION AND ARCHITECTURAL ANALYSIS
OF LITTLE MANOR PLANTATION HOUSE

William Luby Ferguson

A THESIS

Historic Preservation

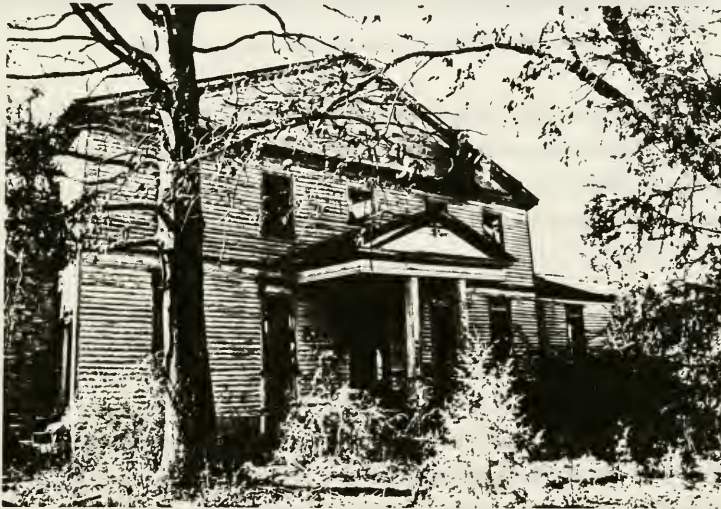
Little Manor is isolated, being in woods where there is no viable access road or functioning utility services. It has been in a steady state of physical decline for the last fifty years and has been deteriorating at an accelerated rate since last occupied in the 1960s. It has been vandalized and now is totally neglected. In the 1940s, the building was documented by noted photographer Frances Benjamin Johnson and studied by architectural historian Thomas Weston Waterman. In 1964, architecture student L. Scott Garner of North Carolina State College (now University), assisted by other students, documented the building with measured drawings. The timing of the latter survey was fortunate, for since that time major sections of the Federal main massing have deteriorated, the east wing chamber has collapsed, all the porches except the main portico are gone, and all doors and window sashes and most of the interior ornamental details have been vandalized or removed. The photograph below shows a view of the north elevation in its current condition. The chimney on the left is the only surviving component of the east wing chamber, the structural integrity of the main massing is tenuous at best, and the main portico is supported by only its two inside square columns.

Figure 2: North Elevation

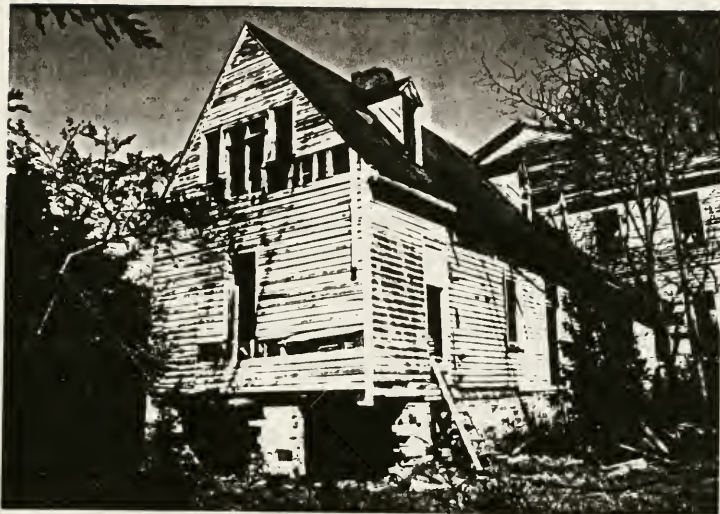
The Georgian section, at the south or rear elevation, has fared better, but as seen in Figure 1 at the top of the next page, it has lost its foundation at the southeast corner and weatherboard has peeled off the south gable and below the eaves of the east elevation.

Figure 3: South and East Elevation of the Georgian Section

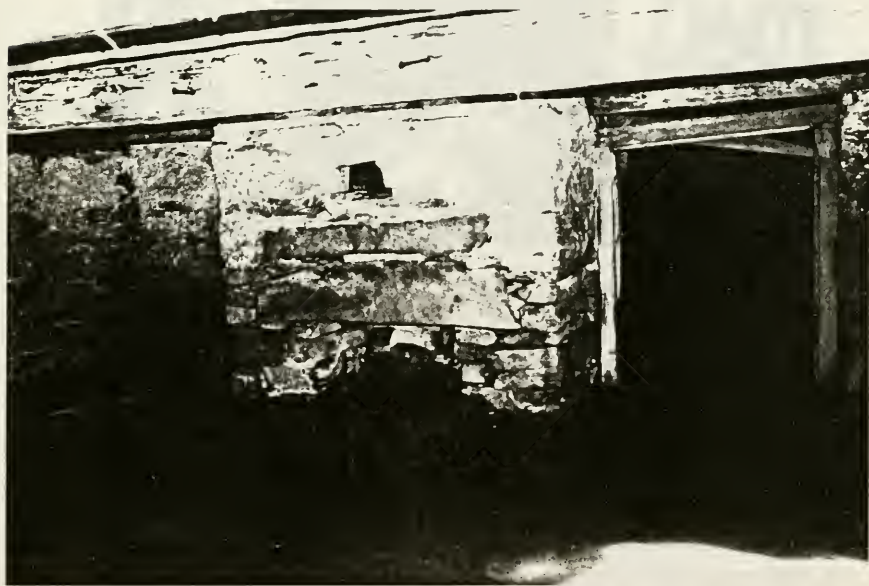
The English basement fireplace is of moderate height, with slightly diagonal cheeks and a deep back. Shown below, its examination was hampered by its being in a foot of water, but the massive lintel is clearly visible.

Figure 39: Georgian English Basement Fireplace (Below Georgian Parlor).

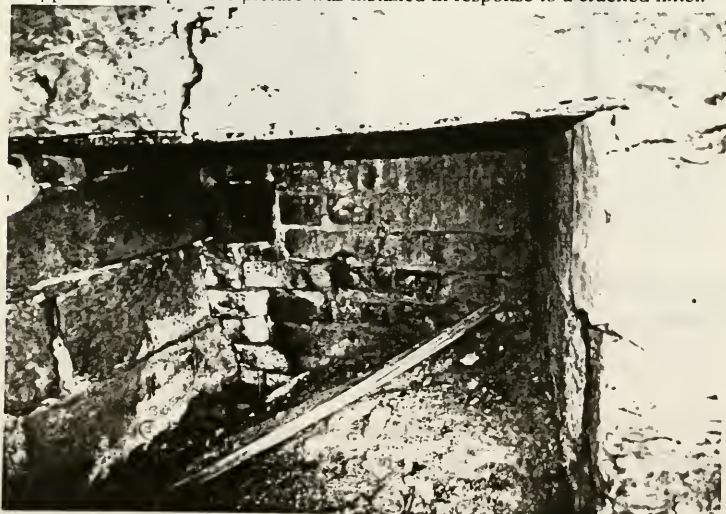
The only other fireplace in the Federal section accessible for examination was the that of the Federal west chamber. Shown below, it has a brick fireback and a relatively low opening. The iron support at the top of the picture was installed in response to a cracked lintel.

Figure 42: Federal West Chamber Firebox

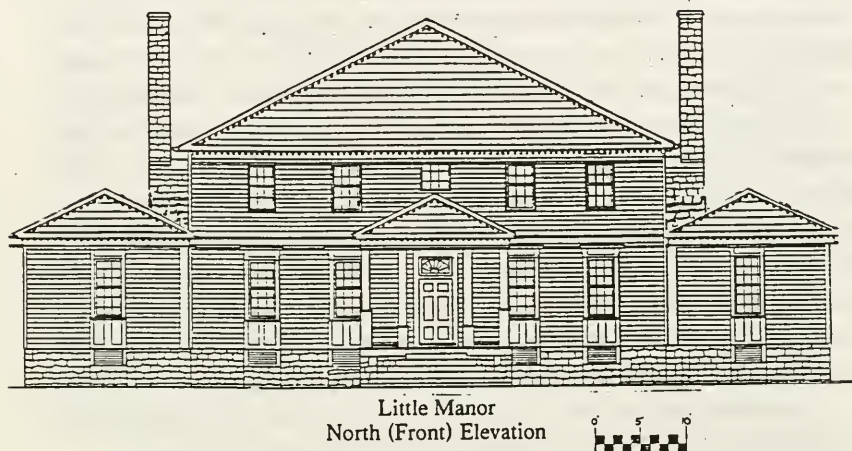
Figure 83: Original Design of Federal North Elevation

Although visually pleasing, the problem with the design is that during rain storms heads of water rush down the roof surfaces of the gables directly onto the chimney and weatherboard of the side elevations of the main massing. Unless very large valley gutters or wide metal flashing materials are used, there is no way the water is prevented from splashing onto the weatherboard and into its overlapping seams. Heads of water can also penetrate into the mortar joints of the chimneys. The result is that these vulnerable areas began to deteriorate rapidly, and the owners were forced to solve the problem by rotating the roof structure to its current form so the flow of water ran off the eaves down onto the ground or into a gutter.

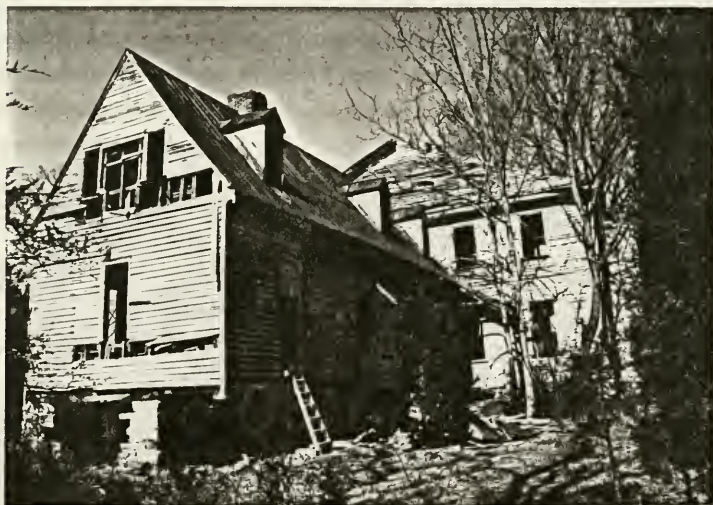
The main causes of deterioration to Little Manor are water penetration, brown rot fungi and most of all, human neglect. Beginning with the foundation, there are two main issues, loss of fabric and flooding. Foundation loss is greatest in the Georgian/cross hall section. Shown in Figure 85, taken from the southeast, all of the foundation has collapsed at the southeast corner. A similar situation has occurred on the west elevation where the cross hall meets the Federal main massing.

Figure 85: Loss of Fabric at Southeast Corner of Georgian/cross hall Section

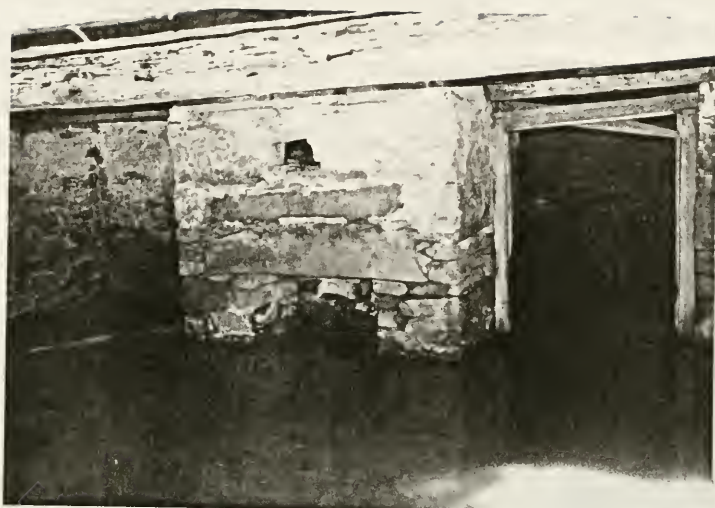
Although the basement the Federal main massing is fairly dry, the basement spaces beneath the Georgian hall and parlor are in a constant flooded condition, being the lowest areas below grade. Seen in Figure 86, under the Georgian parlor, there is one to two feet of stagnant water.

Figure 86: Flooded Basement under Georgian Parlor

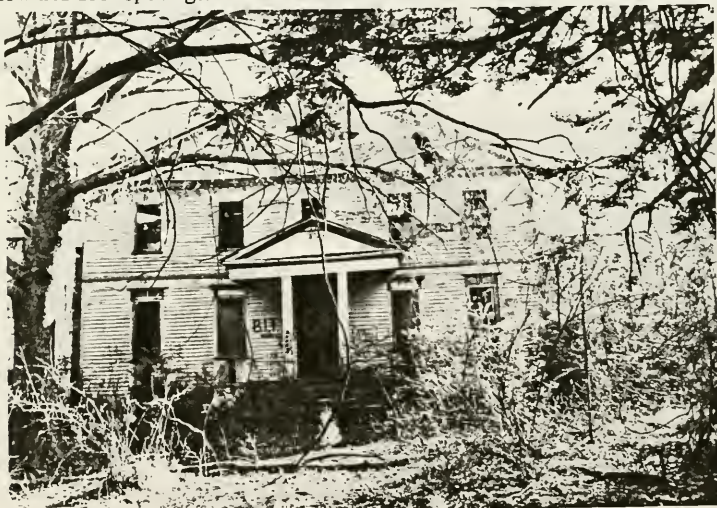
The next three figures show the overall damage to the building's horizontal envelope. Figure 86 shows the Federal north elevation. The east chamber is gone, square columns and foundation elements of the portico are missing, there are holes in the weatherboard and no protection over the window and door openings.

Figure 87: North Elevation Damage

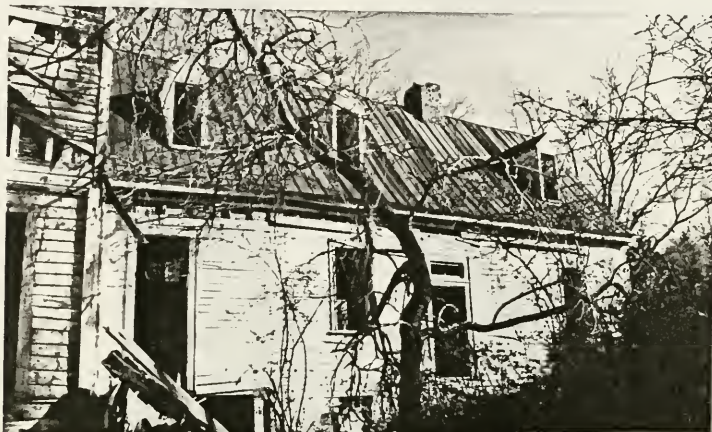
Figure 88: Damage to West Elevation of Georgian/cross hall section

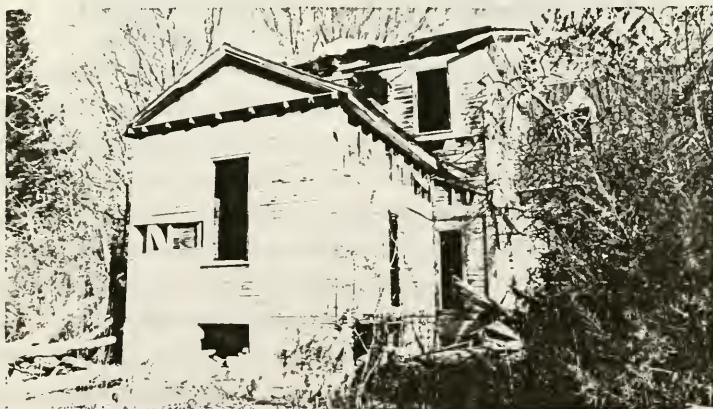
Figure 89: Damage to Federal West Elevation

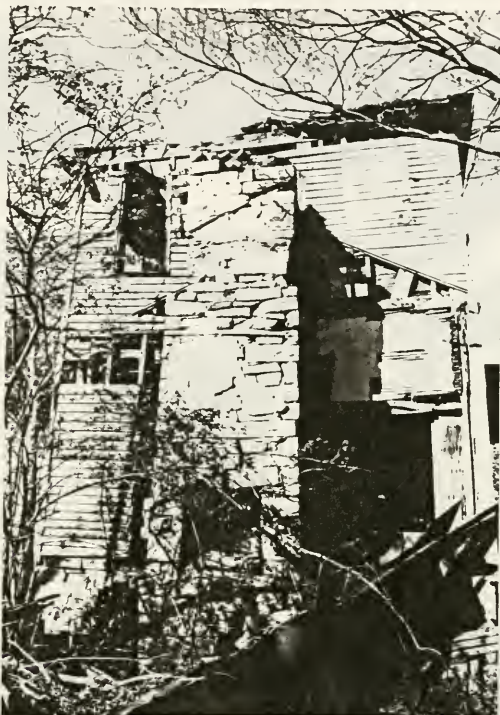
The Federal west chamber has missing siding, but more severe damage has occurred on the second floor of the east elevation Federal main massing, with large holes in the envelope as seen in Figure 89.

Figure 90: Damage to East Elevation of Federal Main Massing

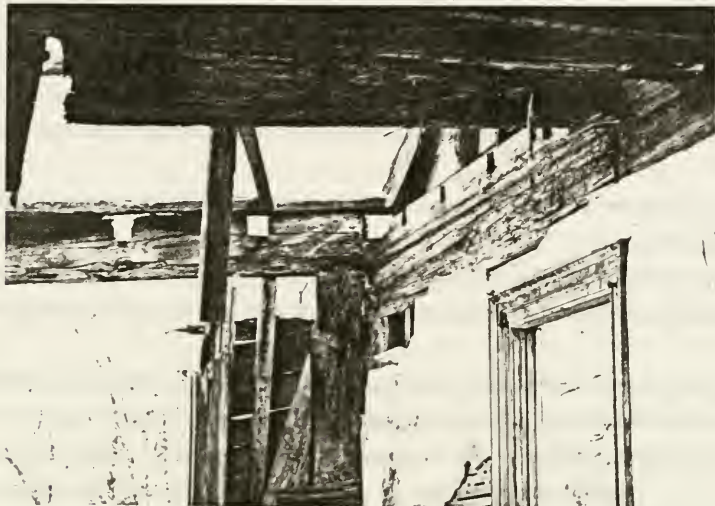
Figure 91: Damaged Roof Near East Elevation of Federal Main Massing
